**Duck Creek Fish Passage Implementation Review**  
**August 29, 2006**  
**Prepared by: Clint Sestrich, Fishery Biologist**

On July 25, 2006 an Implementation Monitoring Review was held for the Duck Creek Fish Passage project. The project was initiated to improve fish passage by eliminating a 3 foot drop at the outflow of the U.S. 191 Duck Creek culvert. For many years rainbow trout spawning in Duck Creek, a major spawning tributary to Hebgen Reservoir, have had to jump approximately 2 ½ - 3 vertical feet into fast flowing water at the outflow of the Duck Creek culvert to access spawning areas in upper Duck Creek and its tributaries in Yellowstone Park. Empirical observation revealed about 1 jump in 10 lead to successful passage of the culvert, implying that a fish had to attempt 10 jumps before successfully passing the culvert and expend excessive energy in the process. Forest Service hydrologists and engineers estimated from the discharge-date graph that migrating rainbow trout could negotiate the culvert for about 6-8 days of the 2-month spawning period. While delayed in a large pool below the culvert, fish were at an increased vulnerability to predators such as otters, osprey

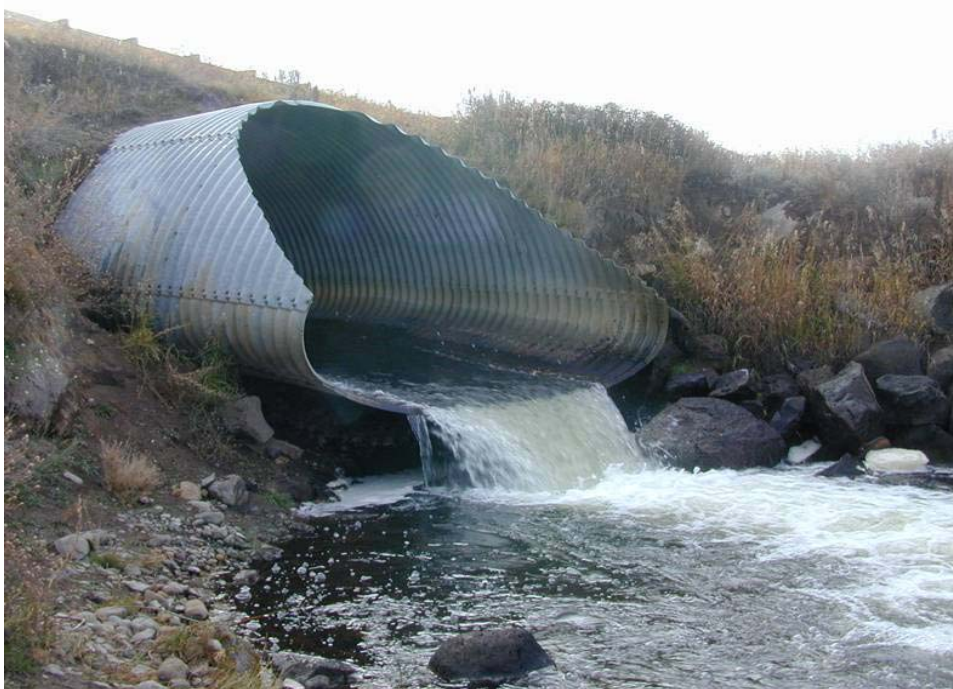
**Figure 1.** U.S. Highway 191 Duck Creek culvert with three-foot drop before constructing the fish passage structure.

1. Although this project substantially increased fish passage through the U.S. 191 culvert, hydrologic conditions inherent to an undersized culvert with a steep lower section are limiting the full potential for fish passage. Therefore, a bridge should eventually be constructed through continued partnership with MDT to completely pass all fish species and size classes throughout the year.

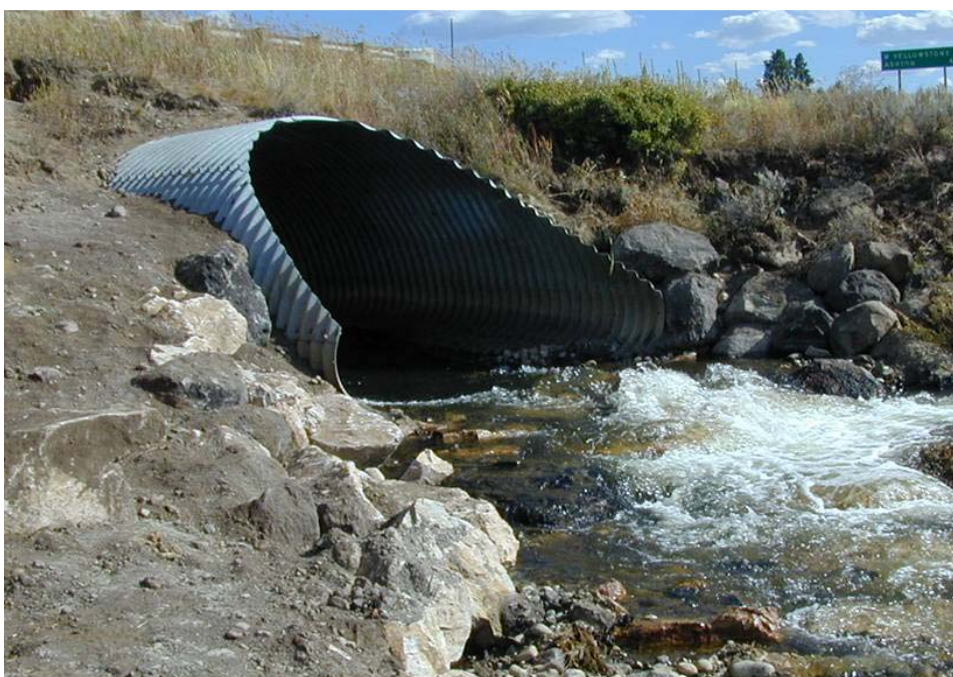
**Figure 2.** Following construction of the boulder cascade, the bottom of the Duck Creek culvert is level with the streambed.

1. The Duck Creek fish passage project was successful at eliminating the jump at the outflow of the U.S. 191 culvert and improving fish passage. The number of out-migrating age-0 mountain whitefish and brown trout increased dramatically from 2005 to 2006 most likely due to increased passage of fall spawning adults in 2005 (Figure 4). In addition, adult rainbow trout captured upstream of the culvert in 2006 comprised smaller size classes than those captured in 2005 indicating that smaller fish were able to pass through the culvert after modification (Figure 5). Although passage has been substantially improved, the culvert remains below Forest Service fish passage standards. The culvert has a steep section at the downstream end with velocities which may continue to impair passage of some fish species with lower swimming performance such as mottled sculpins.

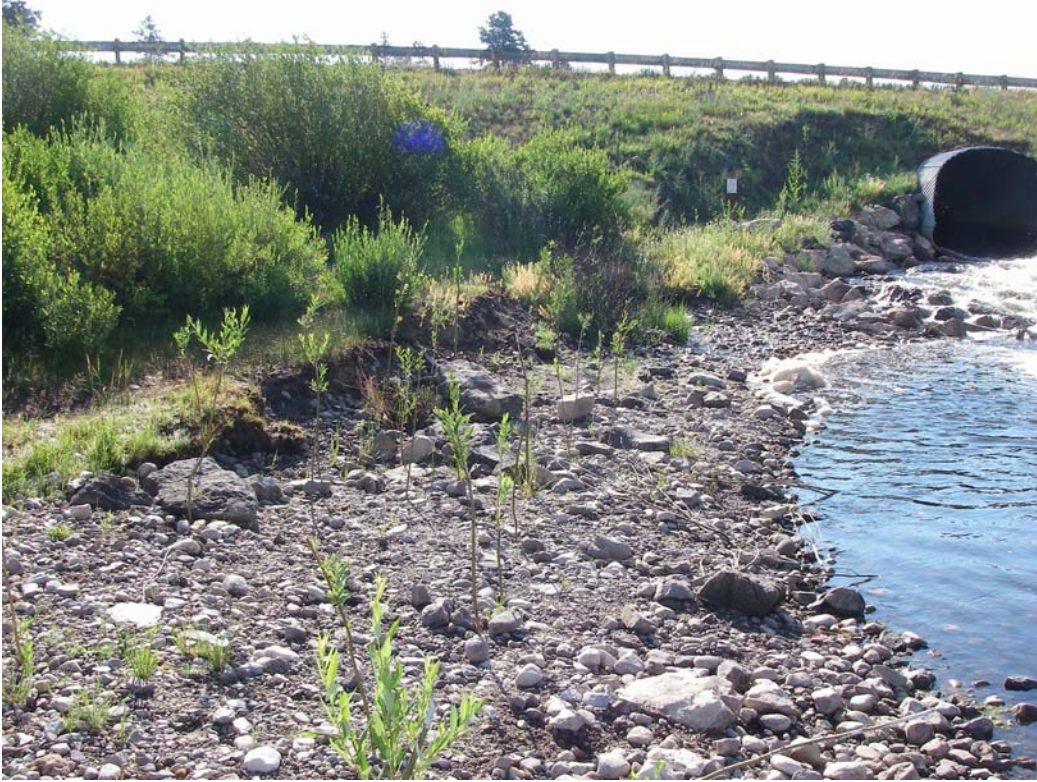
**Figure 3.** Excavator path 45 days after planting willow cuttings. The steep bank to the left of the culvert was treated with coconut mesh erosion control cloth and reseeded with grass in September 2005.

2. Due to its close proximity to U.S. Highway 191, the project site is infested with noxious weeds. However, once willow cuttings mature, they may outcompete shade intolerant weed species.

2. Construction site revegetation should be considered an important fish passage project component and included in design and budget.
3. Erosion is a natural geomorphic process and is usually preferred over unnatural streambank treatments such as rip-rap which actually constrain natural geomorphic process and upset a stream's equilibrium. The streambank downstream of the passage structure was eroding prior to implementing this project and similar eroding banks occur at outcurves further downstream. Therefore it is recommended that no effort should be undertaken to armor the streambank.

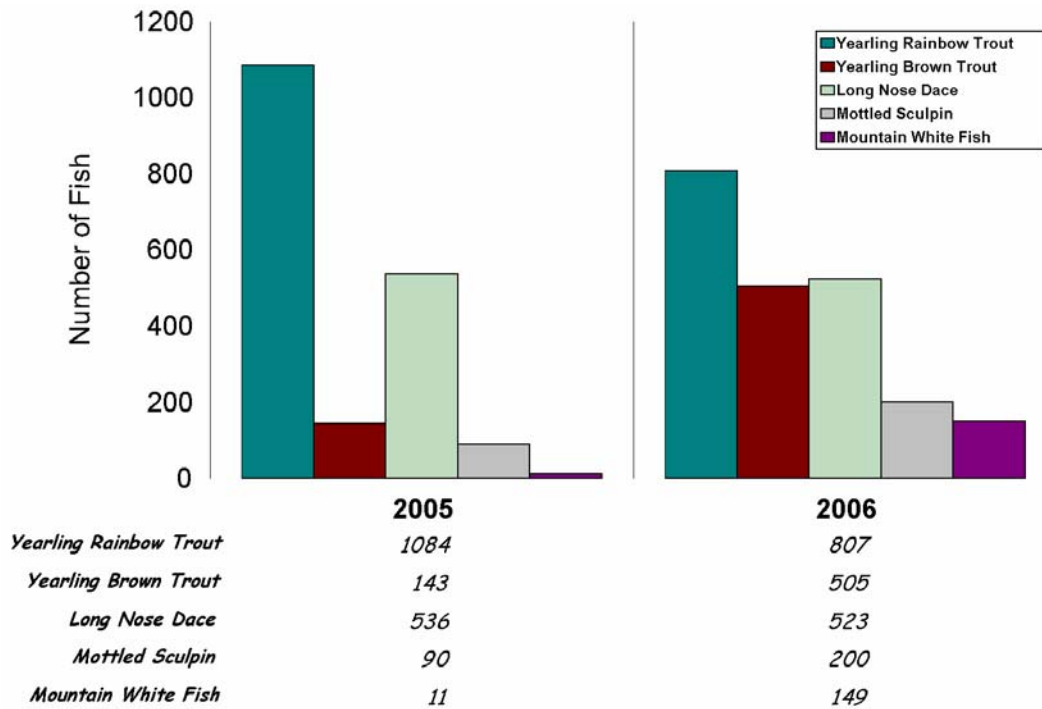
**Figure 4.** Number of out-migrating juvenile fish by species captured in the Duck Creek rotary screw trap during May, June, and July 2005 before the boulder cascade was constructed and 2006 after the cascade was constructed.

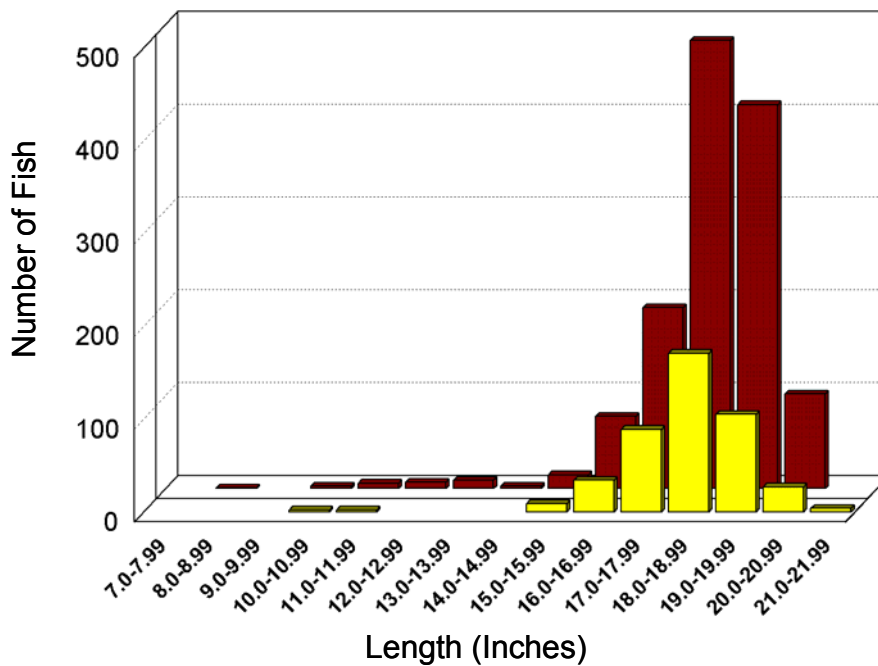
**Figure 5.** Length frequency distribution of adult rainbow trout captured upstream of the Duck Cr. culvert during May and June 2005 (yellow bars) before the boulder cascade was constructed and during May and June 2006 (red bars) after the cascade was constructed.
